Stormwater Master Plan Town of Sandgate, Vermont

December 29, 2017

Fitzgerald Environmental Associates, LLC.
18 Severance Green, Suite 203
Colchester, VT 05446

**Bennington Country
Regional Commission**
111 South Street, Suite 203
Bennington, VT 05201

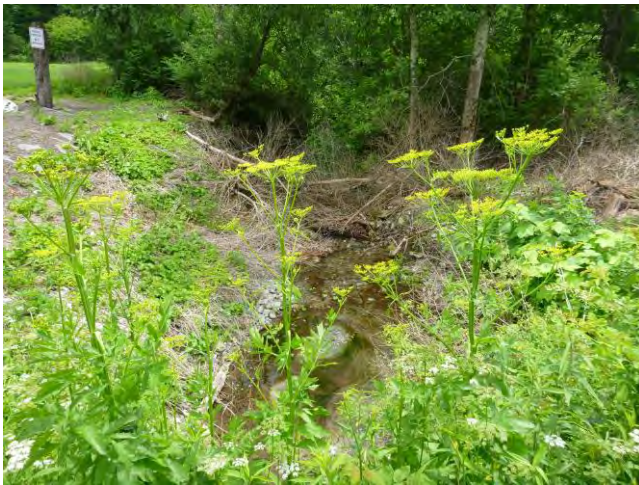
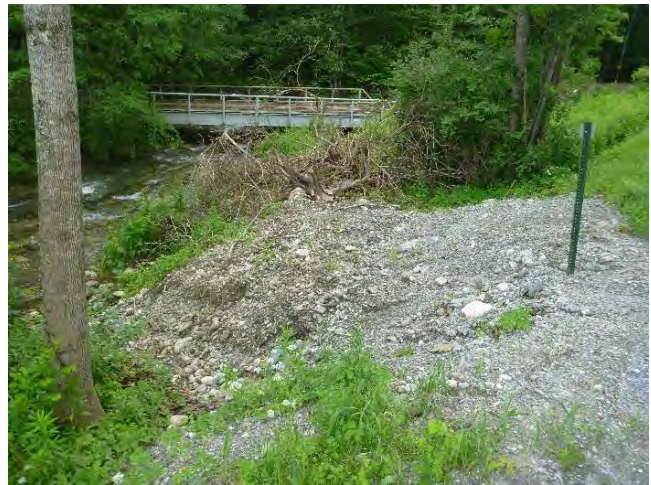
Figure 4: Ditch erosion at a culvert inlet along Woodcock Road (left) was one of the lowest scoring projects (DC-9). Large piles of loose sediment along Sandgate Road (right) following recent culvert and road work were the highest scoring project due partly to its proximity to the stream (DC-14).

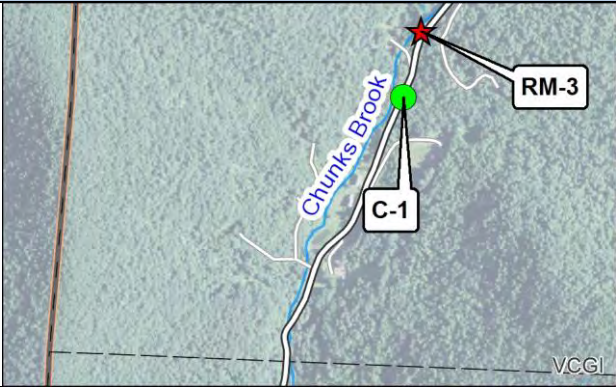
Photo 1: An undersized culvert on Chunks Brook Road.

BMP Description: Replace the undersized structure with a larger structure sized to convey the 25-year flow (e.g. a 6’ wide, 4’ tall squashed corrugated metal culvert with 1’ of embeddedness).

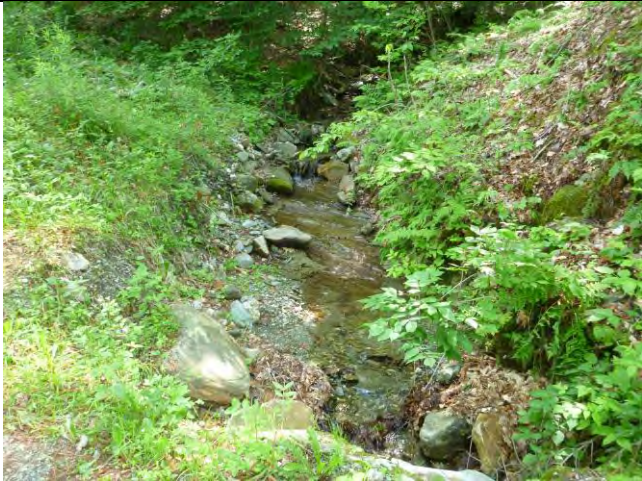
Photo 2: Some bank erosion is present upstream of an undersized culvert on Chunks Brook Road.

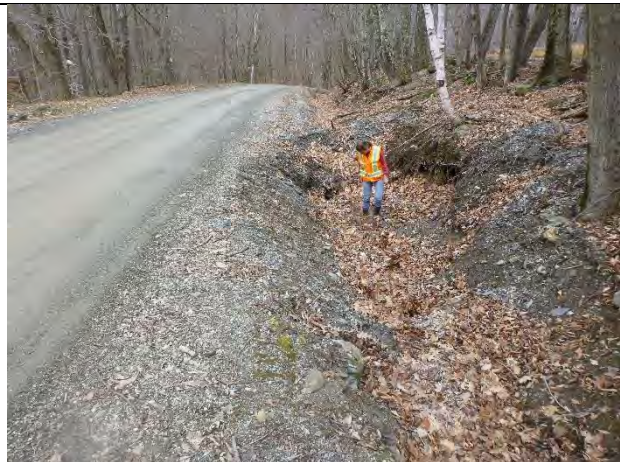
Site Description: 18” diameter corrugated steel culvert under Rupert Road delivers sediment and stormwater to Sandgate Brook. The inlet to the cross-culvert and ditch immediately upstream of the crossing are severely eroded (Photo 1). Additionally, loose gravel is piled alongside the channel downstream of the outlet (Photo 2).

Photo 1: Eroded and unstable ditch upstream of cross-culvert inlet.

BMP Description: Stabilize the road ditch with 12” minus stone. Discontinue dumping loose gravel near outlet.

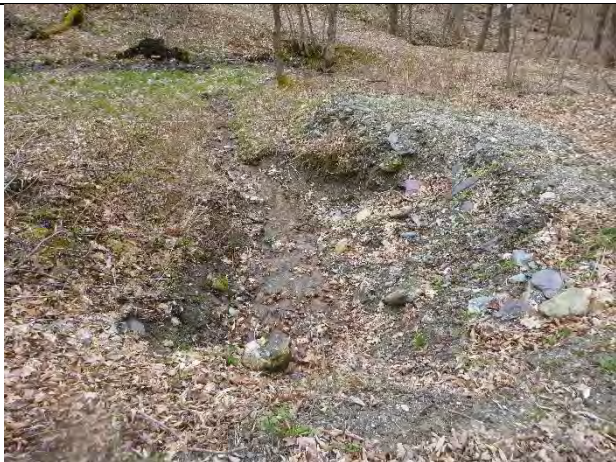
Photo 2: Cross-culvert outlet with gravel dumped alongside channel flowing toward Sandgate Brook.

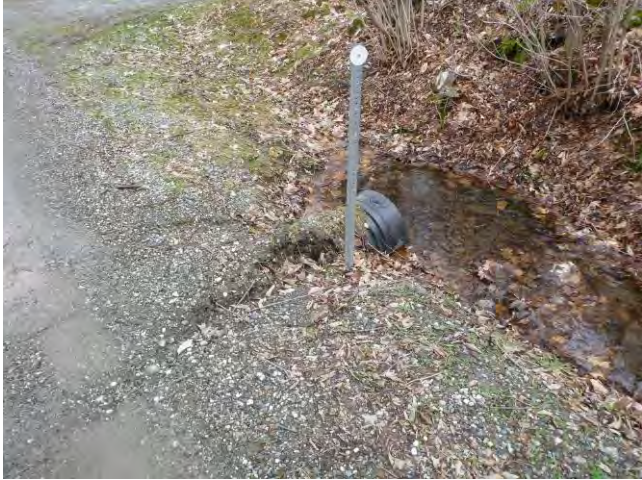
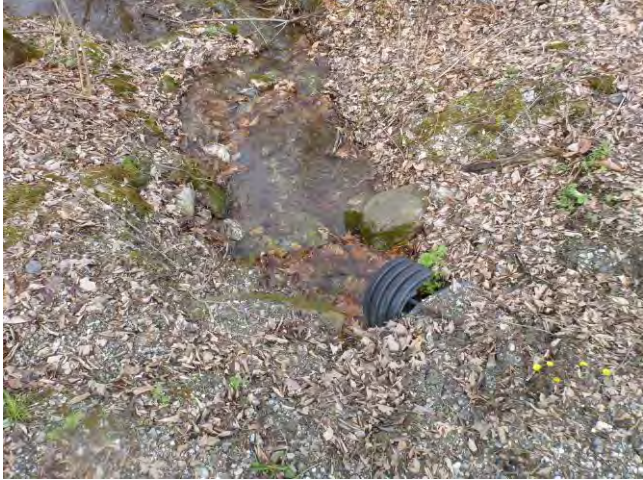
Location:	Snow Road				
Latitude:	43.20632 N				
Longitude:	73.19227 W				
Land Ownership:	Town				
Site Description: Inlet of Snow Road cross-culvert near a first order tributary to Terry Brook has no headwall and is eroded (Photo 1). Additionally, the cross culvert is heaving through the road and the outlet is broken but otherwise stable (Photo 2).

Photo 1: Erosion at the inlet of a Snow Road cross culvert.		Photo 2: Broken Snow Road cross culvert outlet.			
BMP Description: Assess if the culvert needs to be reset at greater depth. Stabilize culvert inlet with stone armor. Stabilize ditch with a minimum of 6-8" minus stone.					
WQ Benefits	Landowner Support and O&M	Infrastructure Resiliency	Cost and Constructability	Additional Benefits	Total Score (Priority)
7	3	2	4	0	16 (Moderate)
Additional Project Benefits Description:

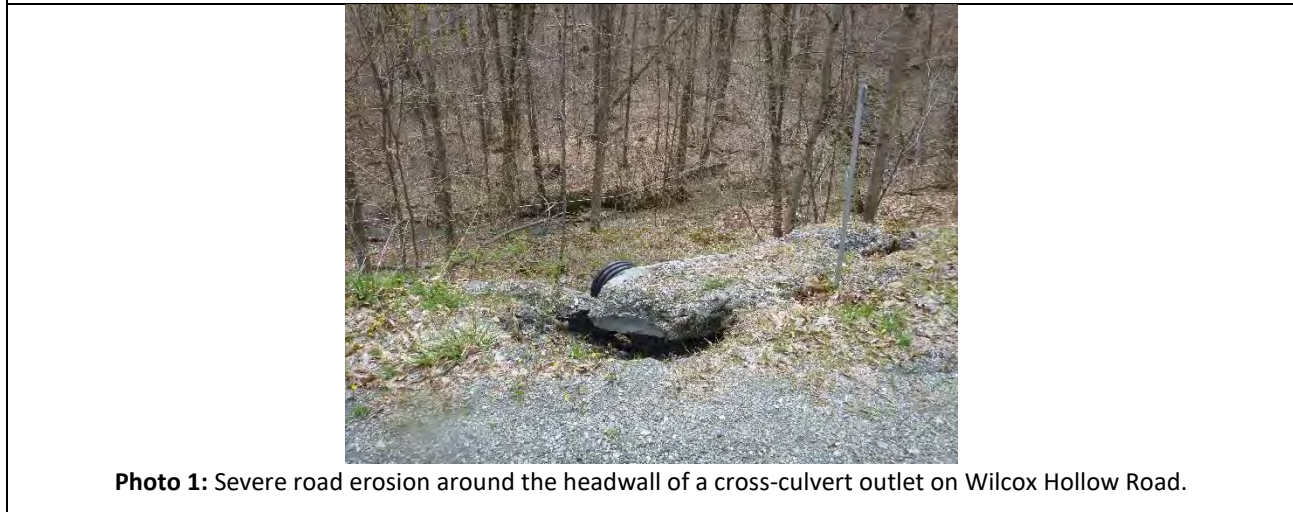
Site Description: Severe road erosion is present behind the headwall of a cross-culvert outlet adjacent to a second order tributary to the Green River (Photo 1).

BMP Description: Crown the road to direct water into the ditch upstream of the cross-culvert inlet. Stabilize cross-culvert outlet as needed.

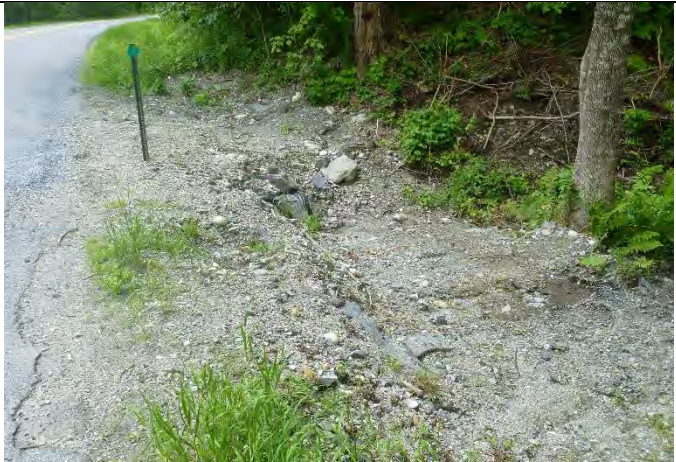
Photo 2: Unstable sediment at a Sandgate Road cross-culvert-inlet.

BMP Description: Clean up the loose sediment piles and stabilize the culvert outlets with rock to prevent scour.

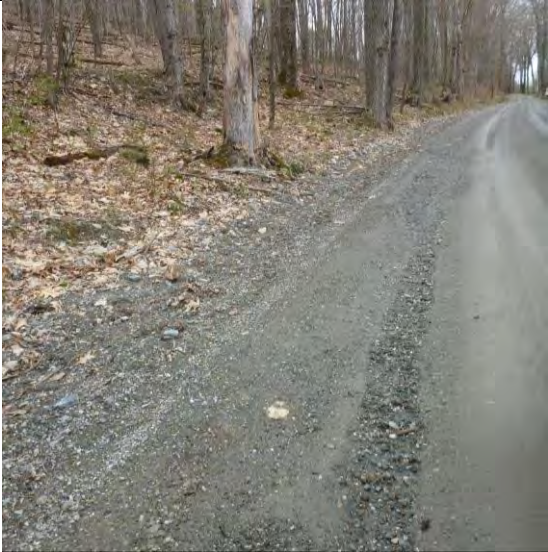
Site Description: A long (1,000ft) section of West Road is set between a steep forested bank and a tall grader berm with mature trees. The ditch along the west side is undersized and there are few opportunities for runoff to leave the road, leading to large areas of rill erosion. (Photo 1).

Photo 1: Rill erosion along the side of West Road.

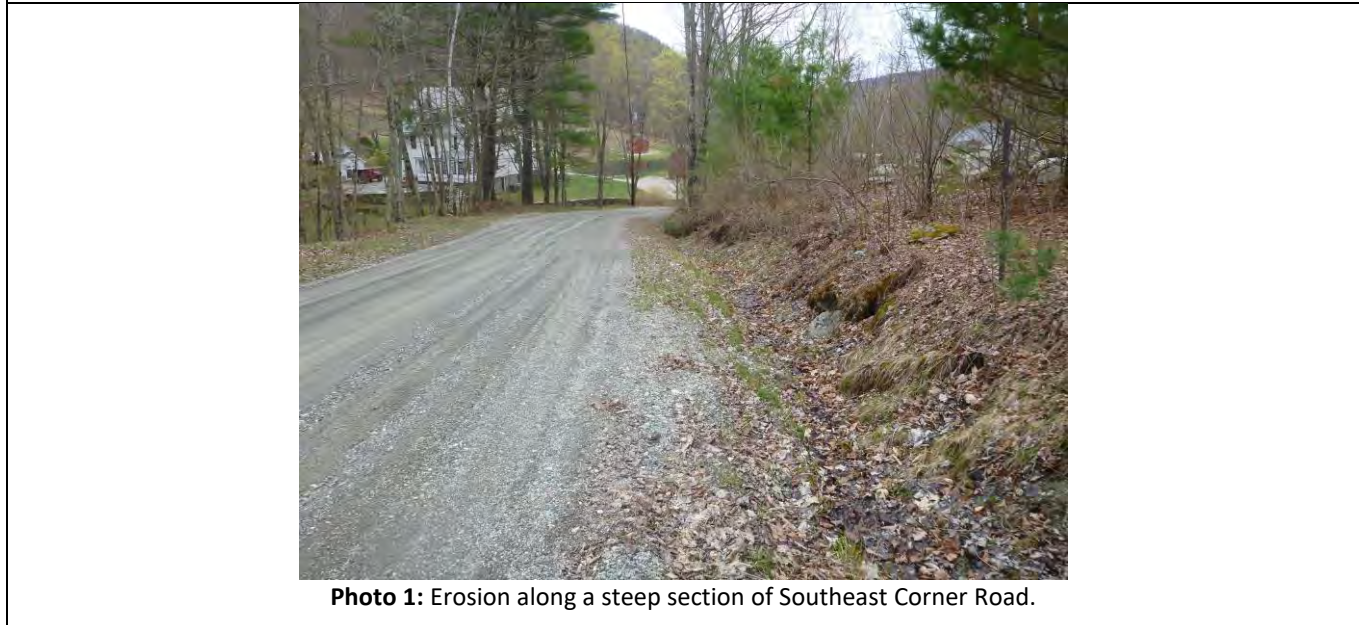
Site Description: Road crown does not effectively direct water into ditch, causing rutting where water runs down this steep section of road (Photo 1).

BMP Description: Crown road to direct water into the existing ditch. Clean out ditch, stabilize the side slope, and line the ditch with 12" minus stone.

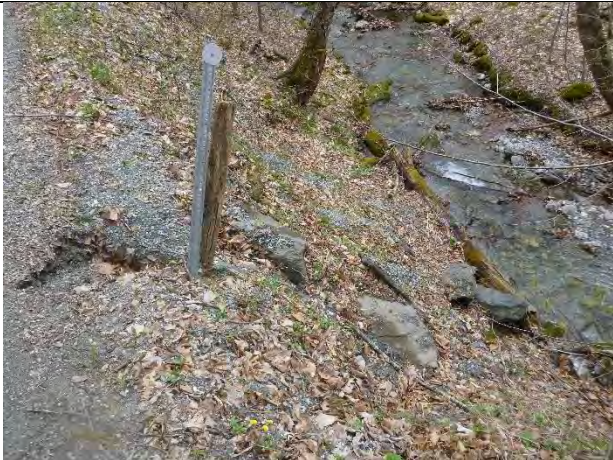
Photo 2: Erosion along the road edge at the cross-culvert outlet adjacent to a second order tributary to the Green River.

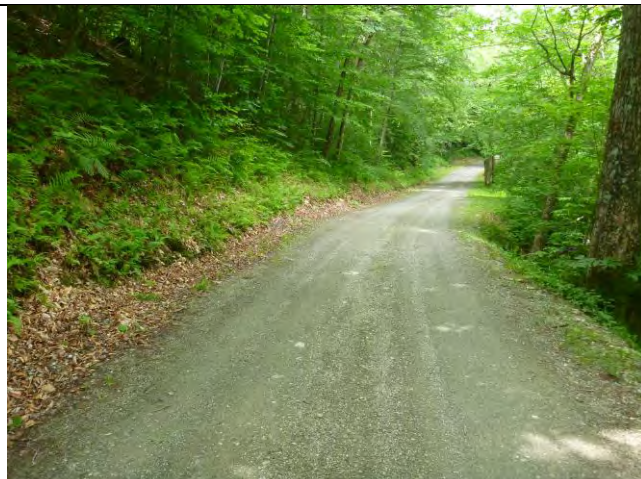
Photo 2: Water currently flowing over the road and eroding the road embankment may be directed into a ditch constructed on the opposite side of the roadway.

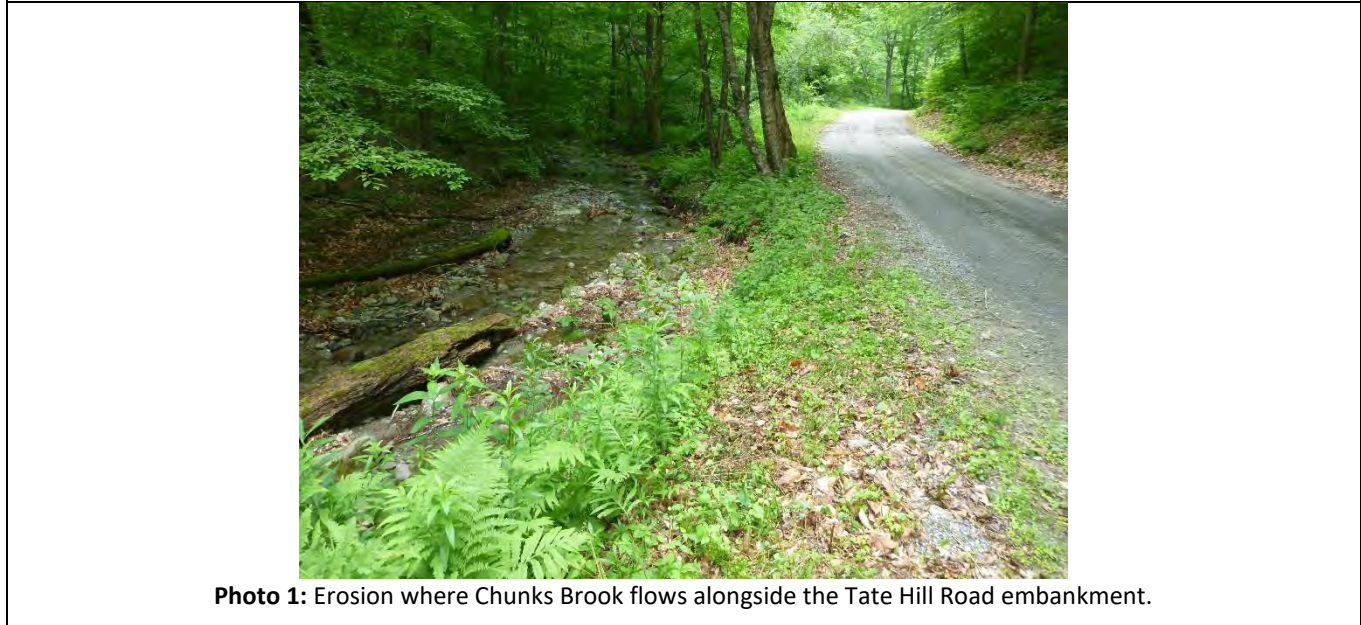
Site Description: Chunks Brook flows alongside Tate Hill Road with no buffer, eroding the stream bank and road embankment (Photo 1).

BMP Description: Armor the road embankment. Crown and ditch road to keep stormwater from flowing across the road to the streambank.

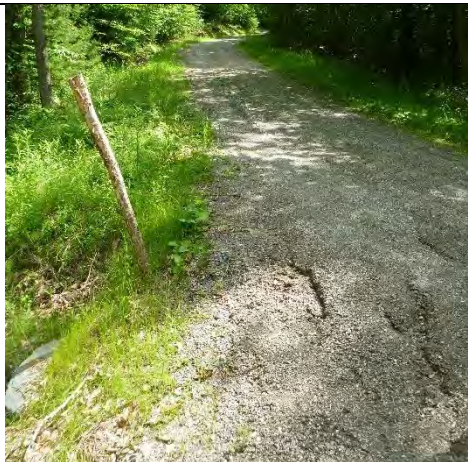
Site Description: Water flows along a steep section of Tate Hill Road eroding the surface and directing sediment toward a culvert where Chunks Brook crosses the road (Photos 1 & 2).

Photo 1: Road erosion to a conveyance at a Chunks Brook stream crossing.

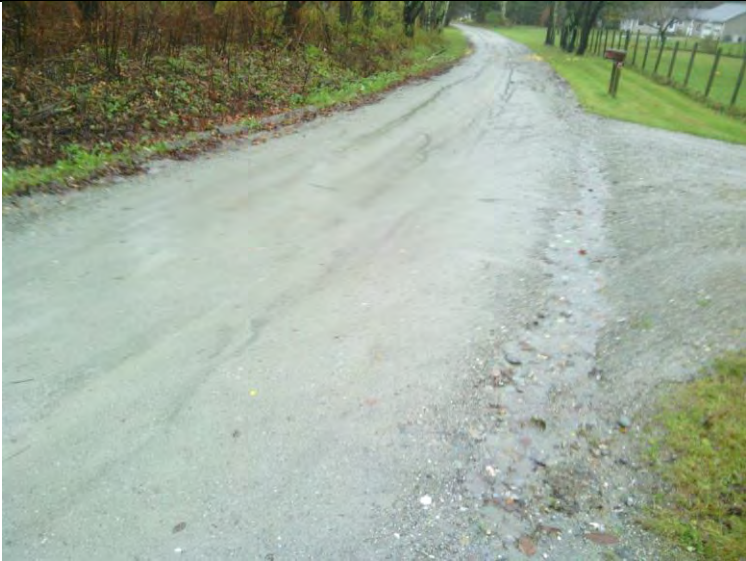
Site Description: Sandgate Road lacks a good crown and drainage ditches (Photo 1). The road elevation sits below adjacent properties in many locations, leading to rilling along the road edge and washouts during spring runoff and heavy rain storms. One existing turnout to the stream is unstable and contributing sediment to the channel. A 15” metal cross culvert is undersized and in fair condition, and has been plugged in the past per RPC culvert inventory data.

Photo 1: Upper section of Sandgate Road at Woods Gift Lane.
Runoff is running along the road edge causing rilling and sedimentation downhill.

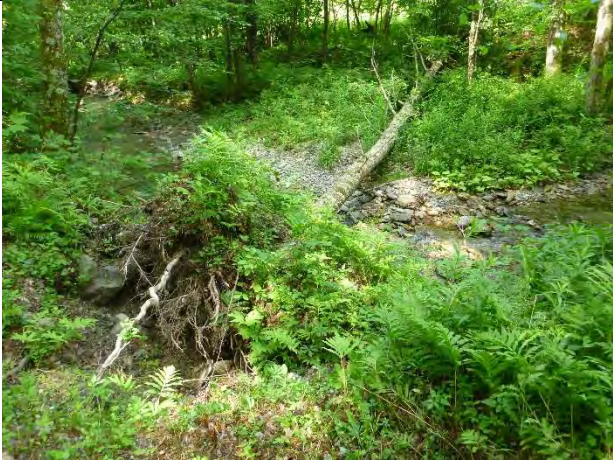
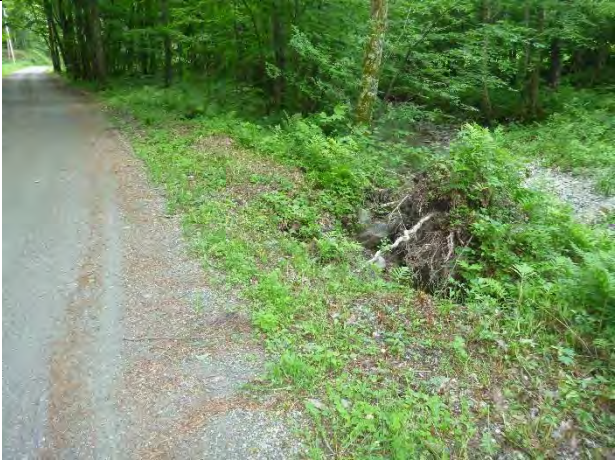
Location:	Chunks Brook Road				
Latitude:	43.12819 N				
Longitude:	73.25531 W				
Land Ownership:	Town				
<p>Site Description: A tree is down across Chunks Brook alongside Chunks Brook road (Photo 1). This creates an erosion hazard for the road by destabilizing the embankment and potentially directing flow toward the road (Photo 2).</p>

<p>Photo 1: Tree down across Chunks Brook.</p>		<p>Photo 2: Exposed embankment along Chunks Brook road.</p>			
<p>BMP Description: Remove tree from channel and armor road embankment. This project requires further review by the ANR River Management Engineer.</p>					
WQ Benefits	Landowner Support and O&M	Infrastructure Resiliency	Cost and Constructability	Additional Benefits	Total Score (Priority)
7	3	3	4	0	16 (Moderate)
<p>Additional Project Benefits Description:</p>					
<p>Project Comments: Moderate priority project due to low cost, potential to increase infrastructure resiliency, and potential to mitigate a nutrient/sediment source to Chunks Brook. We estimate that this project will cost \$5,000 - \$10,000.</p>

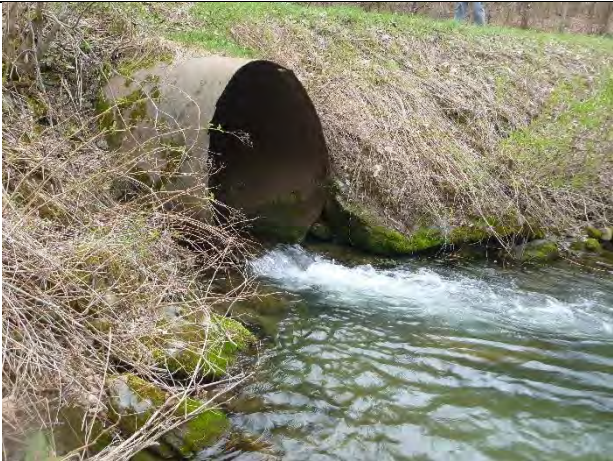
Site Description: 5.3’ diameter rusted repurposed steel tank culvert perched 0.35’ above downstream pool, resulting in reduced Aquatic Organism Passage (AOP) (Photo 1). Additionally, the culvert is hydraulically undersized for the 2.68 mi² watershed.

Photo 1: Outlet drop from Baldwin Brook culvert at West Sandgate Road.

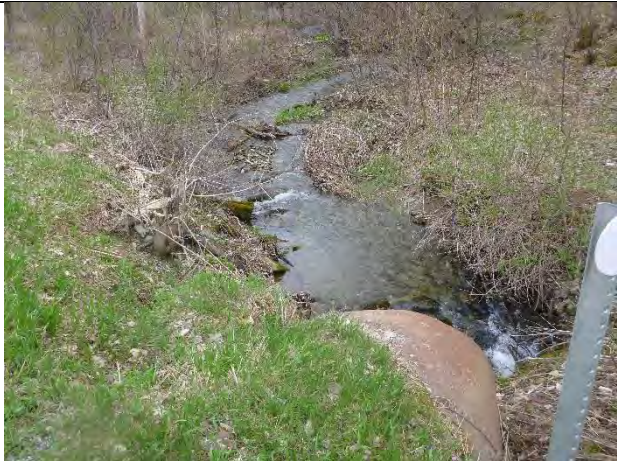
Photo 2: View of downstream channel from roadway. Location of proposed boulder veins to raise tailwater control.

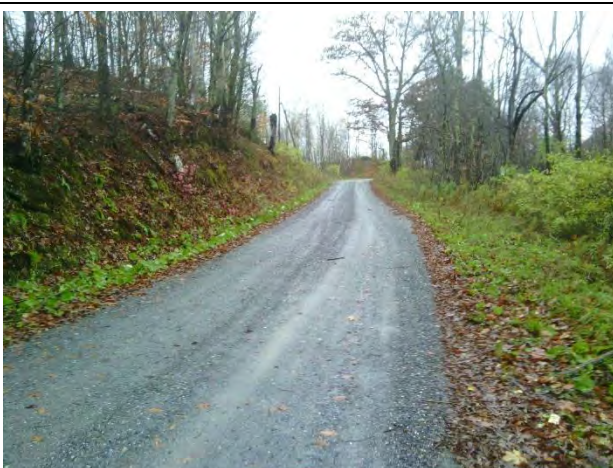
Existing Conditions Notes: The ditches along the steep section of Wuerslin Road show signs of erosion and sedimentation and require stone to meet the MRGP standards. There is no room for a ditch along the west side of the lower road, requiring a new cross culvert. The spur of Wuerslin Road is used infrequently by vehicles and is an ideal location for a stormwater treatment feature. This area is a nuisance maintenance problem for the road foreman. Runoff from the lower part of Wuerslin Road spills onto Sandgate Road causing erosion problems where conveyance features are lacking.

Photo 1: Steep section of upper Wuerslin Road needing stone in ditches and additional cross culverts.

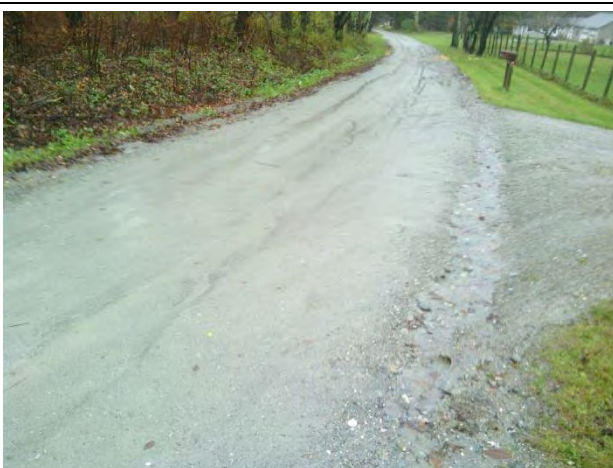
Existing Conditions Notes: Sandgate Road lacks a good crown and drainage ditches. The road elevation sits below adjacent properties in many locations, leading to rilling along the road edge and washouts during spring runoff and heavy rain storms. One existing turnout to the stream is unstable and contributing sediment to the channel. A 15" metal cross culvert is undersized and in fair condition, and has been plugged in the past per RPC culvert inventory data.

Photo 1: Upper section of Sandgate Road at Woods Gift Lane. Runoff is running along the road edge causing rilling and sedimentation downhill.

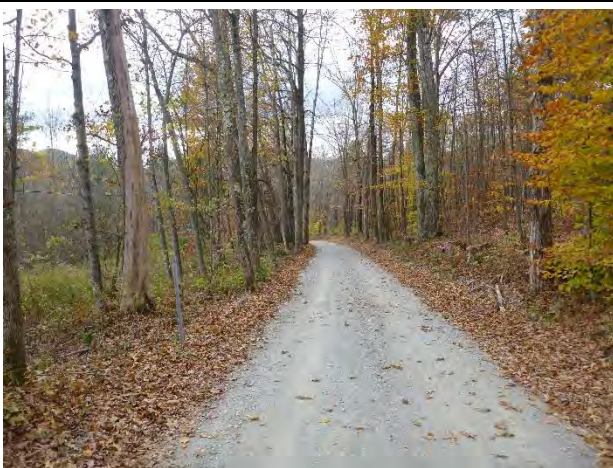
Existing Conditions Notes: The section of West Road from the crest of the hill down to the dry hydrant pond is set between a tall berm with large trees and a relatively steep forested hillslope. The ditch along the west side is shallow and undersized. The road is poorly crowned, and runoff has limited opportunities to leave the road, increasing erosion and sediment loading downstream. The underlying clay soils are prone to extended periods of saturation, increasing road maintenance requirements.

Photo 1: The road has a near continuous tall grader berm (with large trees) along the east side and an undersized and shallow ditch along the west side.

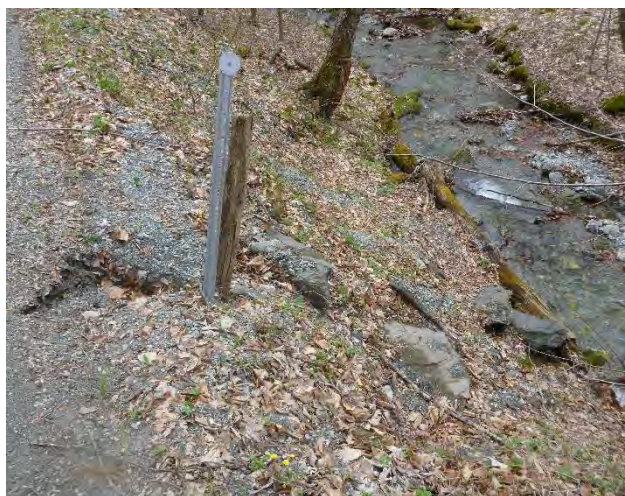
Figure 2: Rilling along the road edge and erosion of the Wilcox Hollow Road cross culvert outfall.
