Stormwater Master Plan Town of Sandgate, Vermont

December 29, 2017

Fitzgerald Environmental Associates, LLC.
18 Severance Green, Suite 203
Colchester, VT 05446

**Bennington Country
Regional Commission**
111 South Street, Suite 203
Bennington, VT 05201

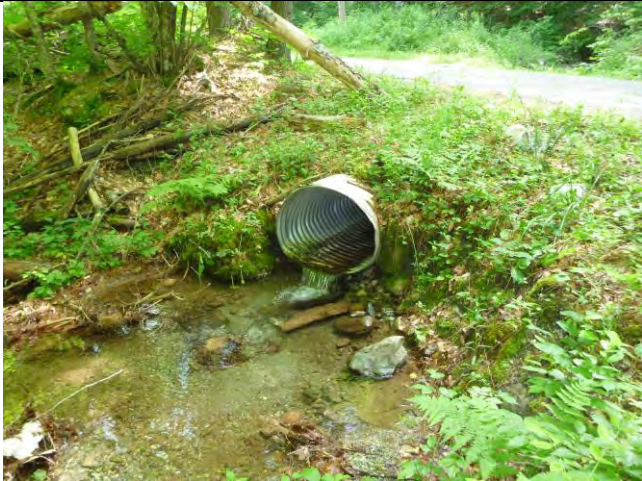
Site Description: An undersized squashed corrugated metal pipe is located on Chunks Brook Road to convey the flow from an unmapped perennial stream draining to Chunks Brook (Photo 1). The culvert capacity is estimated at 40.2 cfs, a flow that may conservatively be exceeded in the 10-year flood event. Additionally, the culvert is perched and there is erosion upstream of the culvert inlet increasing sediment load to Chunks Brook (Photo 2).

Photo 1: An undersized culvert on Chunks Brook Road.

BMP Description: Replace the undersized structure with a larger structure sized to convey the 25-year flow (e.g. a 6’ wide, 4’ tall squashed corrugated metal culvert with 1’ of embeddedness).

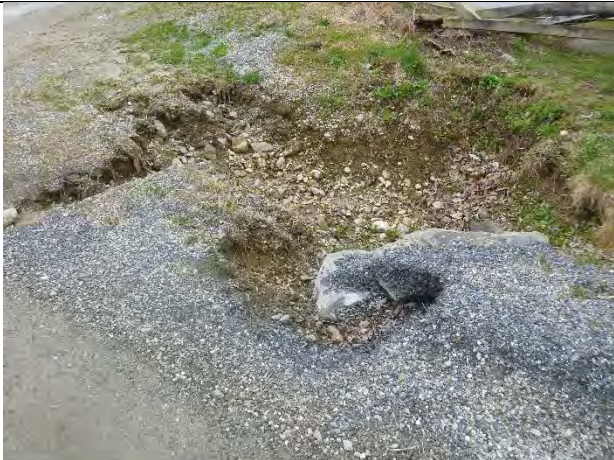
Site Description: Roadside ditch along West Sandgate Road is filled with sediment, causing runoff to scour around the edge of the roadway at the inlet of an 18” corrugated plastic cross-culvert. Severe gully erosion is present at the culvert inlet and along the road edge (Photos 1 & 2).

Photo 1: Severe gully erosion along the road edge and at the cross-culvert inlet.

BMP Description: Clean out ditch upstream of cross-culvert and crown road to direct water into the ditch. Stabilize erosion areas.

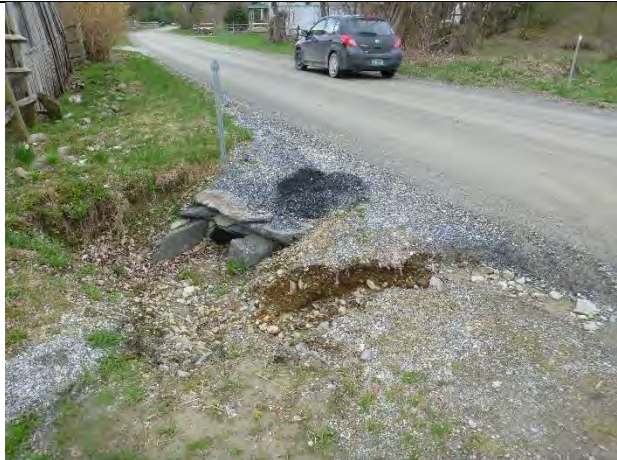
Photo 2: Filled in, poorly defined ditch with erosion where runoff flows along the road over the culvert inlet.

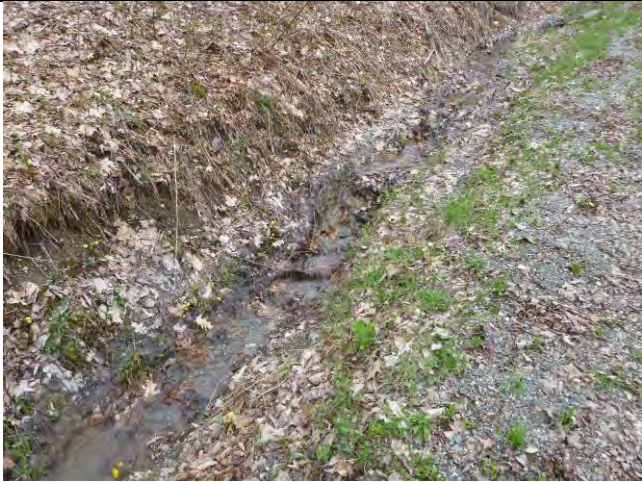
Site Description: Inlet of a West Road cross-culvert and ditch upstream are eroded with an active headcut (Photo 1). Outlet is eroded with a 3' perch and drains to a second order tributary to Baldwin Brook (Photo 2).

Photo 1: A headcut and erosion in the ditch upstream of a West Road cross culvert.

BMP Description: Stabilize culvert inlet and outlet with coarse material. Stabilize road ditch with of 12" minus stone. Grade road ditch at inlet to remove headcut. Improve armor at the culvert outlet to reduce scour.

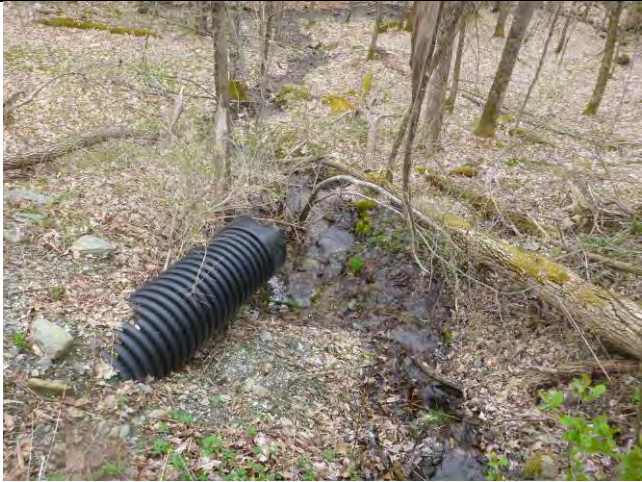
Photo 2: Erosion at the perched outlet of a West Road cross culvert.

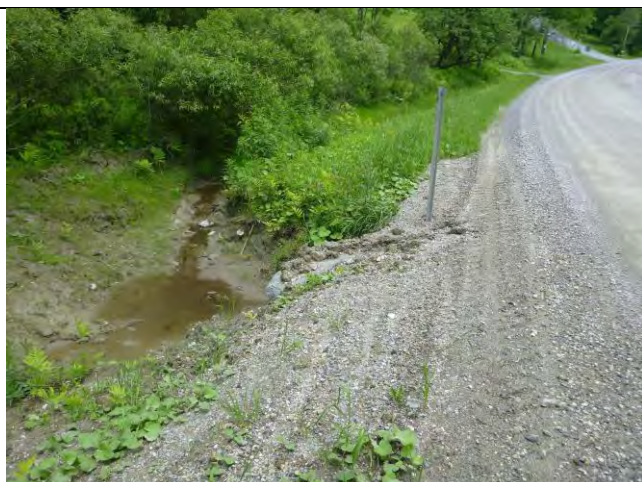
Site Description: Water exits roadway at a drainage culvert near the gravel-pavement transition on Sandgate Road, eroding the road embankment and pushing sediment into a wetland upstream of the culvert (Photo 1) and the Green River (Photo 2).

Photo 1: Water flowing over Sandgate Road is causing erosion at a cross culvert inlet, acting as a source of sediment to a roadside wetland.

BMP Description: Crown the road to direct water into ditches upstream of the cross-culvert inlet. Vegetate area upstream and downstream of cross culvert. Install a stone lined turnout near the culvert if necessary.

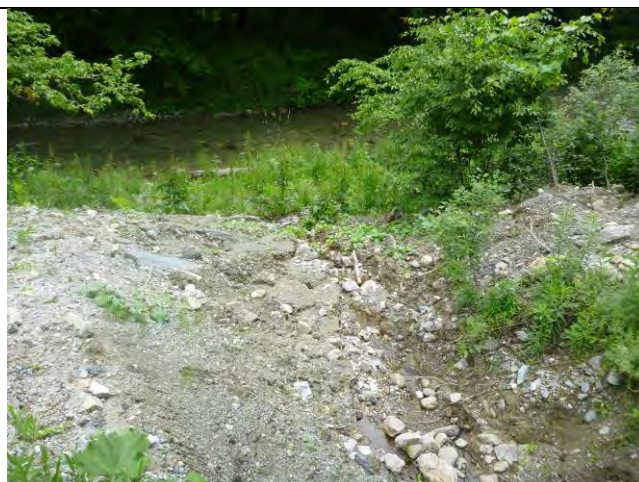
Photo 2: Erosion at a Sandgate Road cross culvert outlet is acting as a source of sediment to the Green River directly downstream.

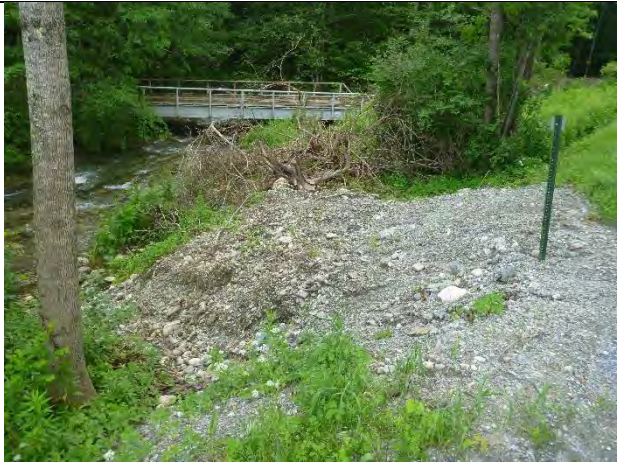
Site Description: Unstable sediment associated with a series of culvert installations along Sandgate Road is piled alongside the Green River, a potential contributor to sediment loading (Photo 1). Sediment is also piled along the upstream side of the drainage culverts, which may plug the culverts (Photo 2).

Photo 1: Sediment piled on a road embankment adjacent to the Green River.

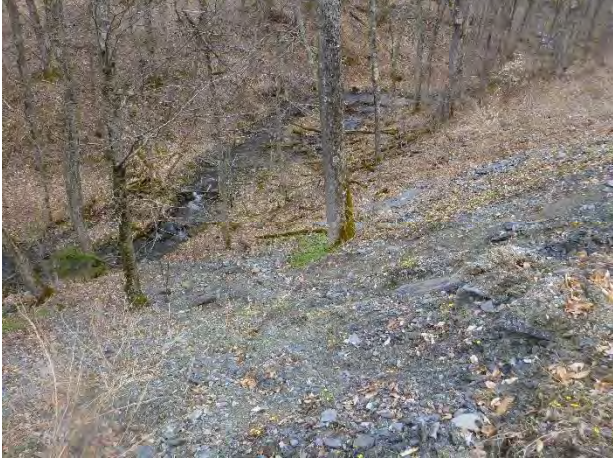
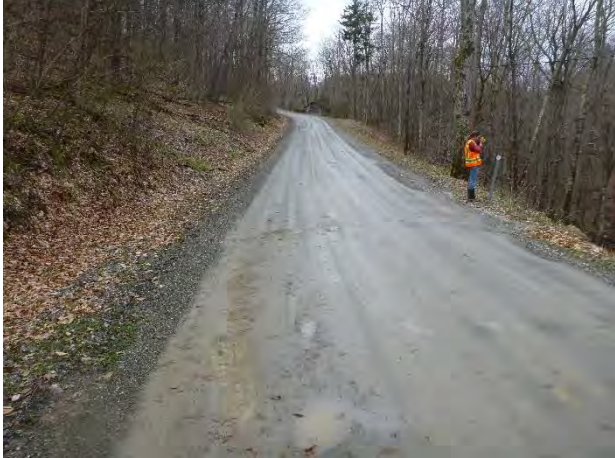
Location:	Rupert Road south of West Road				
Latitude:	43.19535 N				
Longitude:	73.20220 W				
Land Ownership:	Town				
<p>Site Description: The road crown along a portion of Rupert Road, directs water away from the ditch to a steep slope on the northwest side of the road above Terry Brook. Road runoff has eroded an approximately 50'-tall gully that conveys sediment from the road toward the brook and threatens the road (Photo 1).</p>

<p>Photo 1: Massive gully conveying sediment toward Terry Brook.</p>		<p>Photo 2: Road grade conveying runoff toward the steep slope and brook, rather than the existing ditch and cross-culvert.</p>			
<p>BMP Description: Crown the road into the existing ditch and 18" corrugated steel cross-culvert on the southeast side of the road (Photo 2). Enlarge the ditch. Install log terraces and stone to stabilize road embankment slope as needed.</p>

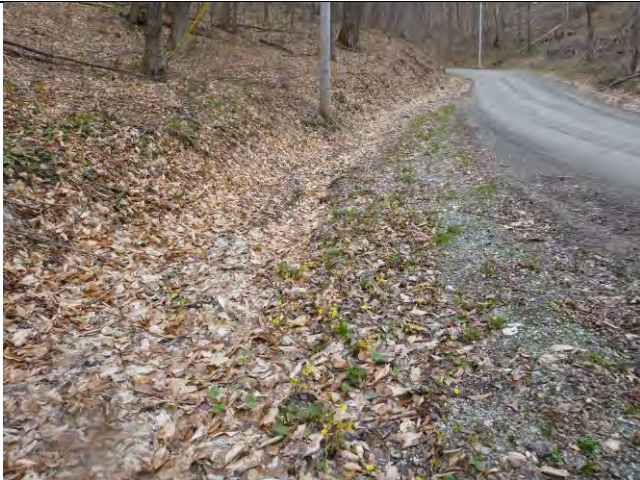
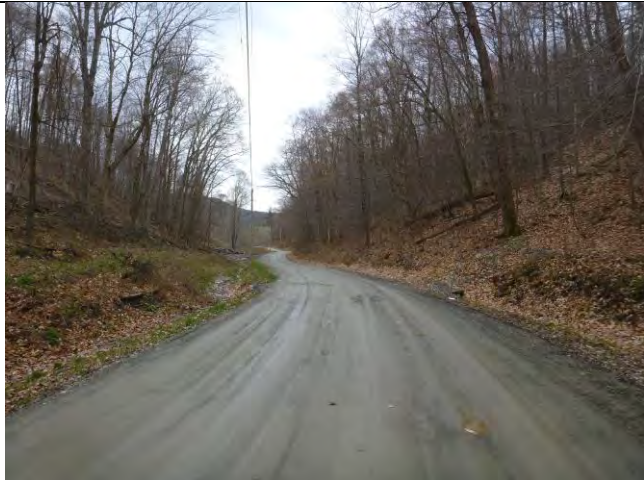
Location:	Rupert Road				
Latitude:	43.17534 N				
Longitude:	73.21447 W				
Land Ownership:	Town				
Site Description: The road crown along a section of Rupert Road does not effectively direct water into the roadside ditch (Photo 1) and the ditches are poorly formed and eroding (Photo 2). The erosion is located near a first order tributary to Baldwin Brook.

Photo 1: The road crown on a section of Rupert Road is not effectively directing water into the roadside ditches.			Photo 2: Ditches along a section of Rupert Road are poorly formed and eroding.		
BMP Description: Crown road to direct water into ditch. Enlarge ditch and line with 8" to 12" minus stone.					
WQ Benefits	Landowner Support and O&M	Infrastructure Resiliency	Cost and Constructability	Additional Benefits	Total Score (Priority)
6	3	1	4	0	14 (Moderate)

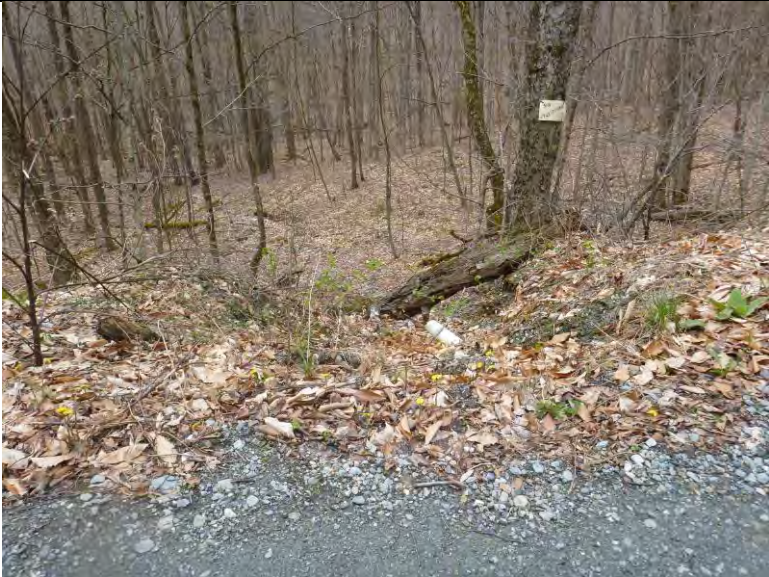
Location:	West Road				
Latitude:	43.16863 N				
Longitude:	73.22927 W				
Land Ownership:	Town				
Site Description: Road crown does not effectively direct water into ditch, causing rutting where water runs down the road. Ditches spill across the road, eroding the roadway and embankment (Photo 1).

Photo 1: Erosion and sediment loss along a steep section of road embankment upslope of a tributary to Baldwin Brook.					
BMP Description: Improve road crown and enlarge the ditch.					
WQ Benefits	Landowner Support and O&M	Infrastructure Resiliency	Cost and Constructability	Additional Benefits	Total Score (Priority)
6	3	1	5	0	15 (Moderate)
Additional Project Benefits Description:					
Project Comments: Moderate priority project due to the potential to mitigate a sediment source to a Baldwin Brook tributary and the low cost of the project. We estimate that this project will cost \$5,000 to \$15,000.

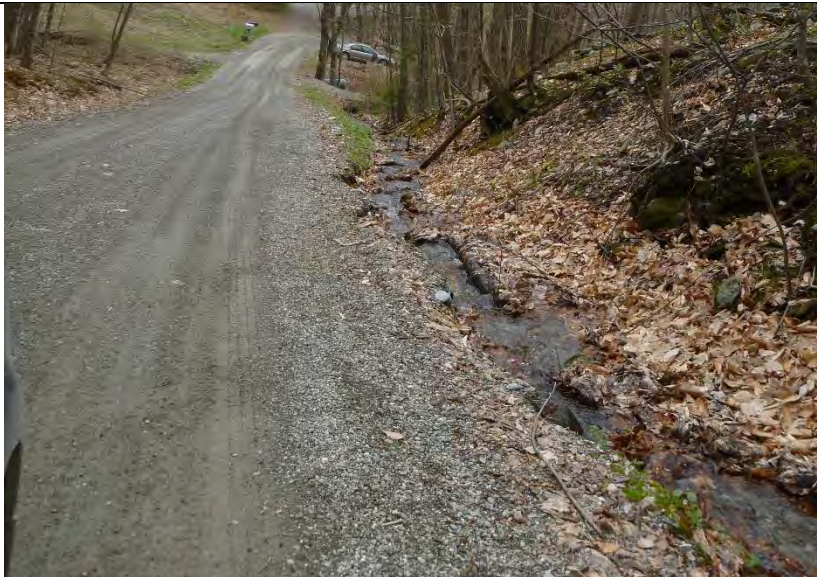
Location:	Southeast Corner Road				
Latitude:	43.13343 N				
Longitude:	73.17889 W				
Land Ownership:	Town				
Site Description: Erosion along the edge of a steep section of Southeast Corner Road due to an unstable ditch that is relatively full of material. A first order tributary to a third order Green River tributary runs alongside the road (Photo 1).

Photo 1: Erosion of steep section of Southeast Corner Road.					
BMP Description: Clean out ditch and stabilize with a minimum of 6-8" minus stone. Steeper ditch sections require 12" minus stone.					
WQ Benefits	Landowner Support and O&M	Infrastructure Resiliency	Cost and Constructability	Additional Benefits	Total Score (Priority)
8	3	2	4	2	19 (High)
Additional Project Benefits Description: This problem area is a high-visibility water quality impact, where a third order Green river tributary runs alongside Sandgate Road and creates a chronic problem area for road erosion.

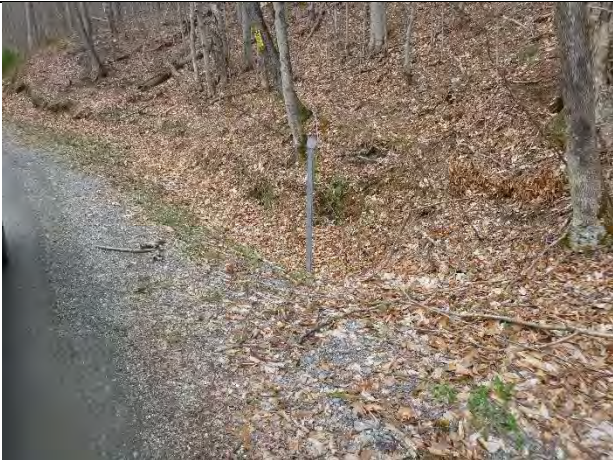
Photo 1: Ditch upstream of cross-culvert inlet on Wilcox Hollow Road is filled in, causing water to follow the road.

BMP Description: Replace cross-culvert with an 18” at a higher slope to reduce outlet drop. Stabilize the road edge and add an appropriate header and footer at the culvert outlet, stabilize the outflow channel to stream.

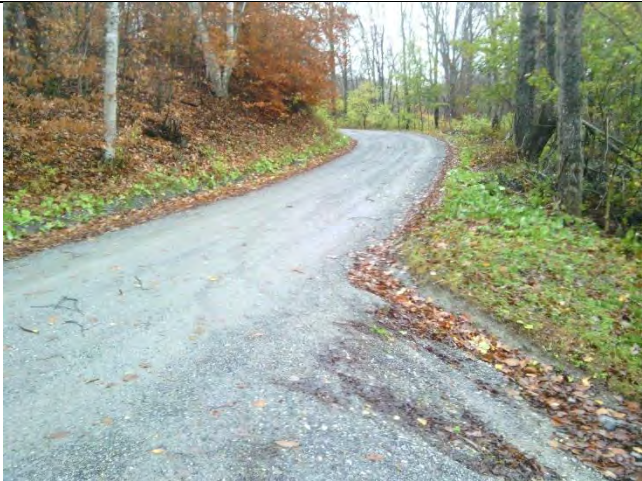
Photo 1: Runoff down a steep portion of Wuerslin Road is causing erosion at the secondary turn to Sandgate Road.

BMP Description: Improve ditches along Wuerslin Road and install a stormwater treatment feature along the side of the road at the spur.

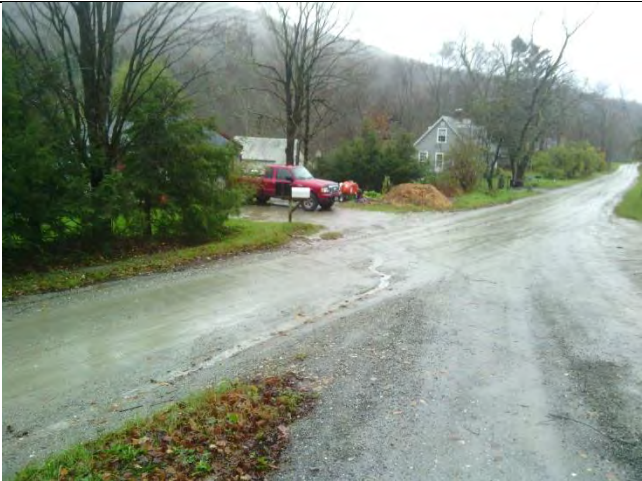
Photo 2: Runoff from Wuerslin Road causing significant erosion as it crosses Sandgate Road.

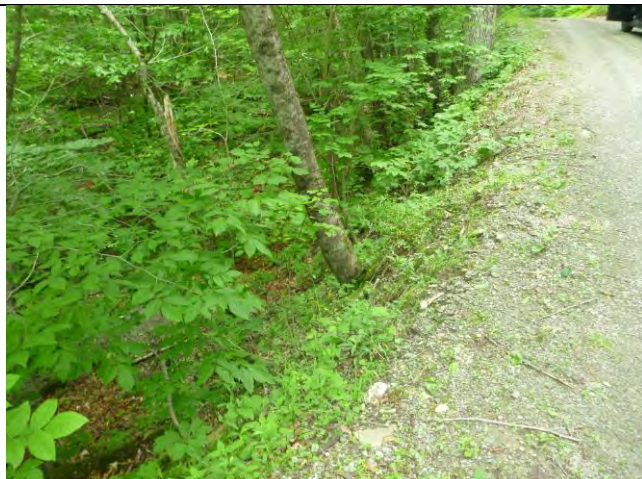
Site Description: Water flows along Tate Hill road, causing erosion along steep road embankments adjacent to Chunks Brook (Photo 1).

Photo 1: Erosion of a steep road embankment along Tate Hill Road.

BMP Description: Install a ditch on the opposite side of the road (Photo 2) and crown the road to direct water into the ditch. At least one cross-culvert is recommended.

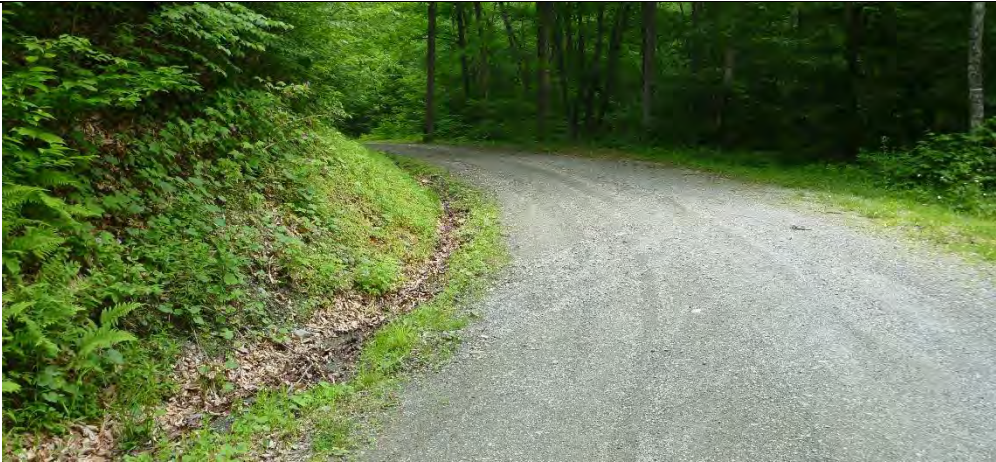
Location:	Tate Hill Road				
Latitude:	43.13347 N				
Longitude:	73.24682 W				
Land Ownership:	Town				
Site Description: Water flows across a steep section of Tate Hill Road, eroding the roadway (Photo 1).

<p style="text-align: center;">Photo 1: Erosion of steep section of Tate Hill Road.</p>					
BMP Description: Clean out ditches and line with stone, crown road to direct water into ditches.					
WQ Benefits	Landowner Support and O&M	Infrastructure Resiliency	Cost and Constructability	Additional Benefits	Total Score (Priority)
7	3	1	5	0	16 (Medium)
Additional Project Benefits Description:					
Project Comments: Moderate priority project due to low cost and potential to mitigate a sediment source to Chunks Brook. We estimate that this project will cost \$5,000 to \$10,000.

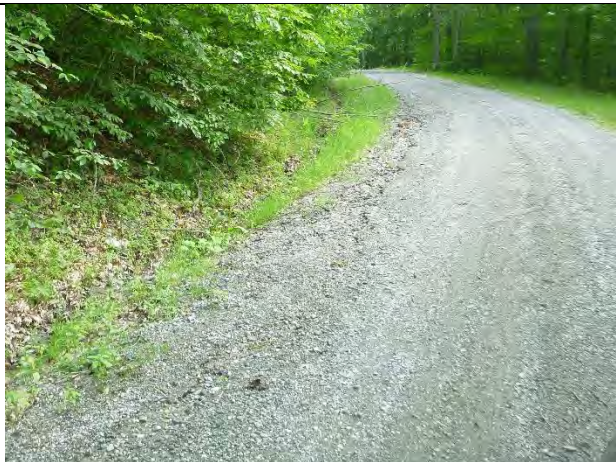
Photo 2: Road erosion along a steep section of Chunks Brook Road.

BMP Description: Crown road to direct water into ditches. Excavate and stabilize ditches with stone as needed.

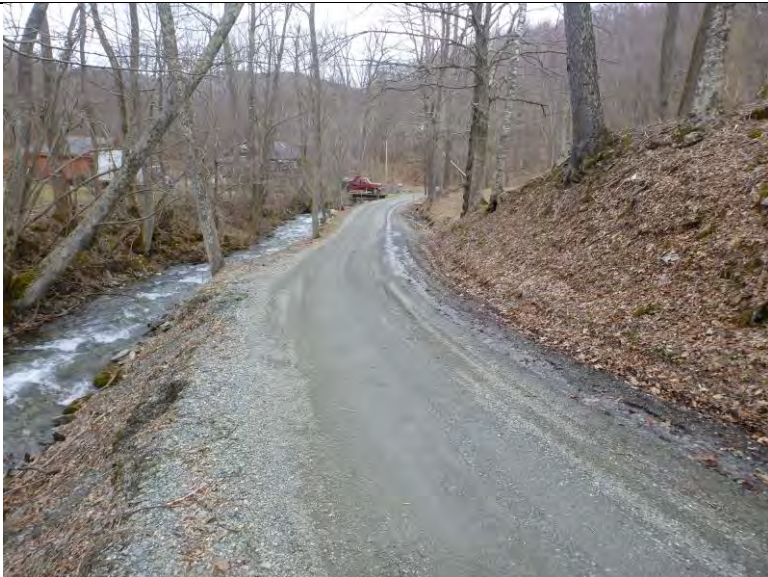
Location:	Upper Hamilton Hollow Road				
Latitude:	43.14623 N				
Longitude:	73.17533 W				
Land Ownership:	Town				
Site Description: Limited space along north side of road for drainage from Merritt residence down along Hopper Brook. Road erosion and rilling along the road leading to sedimentation in brook (Photo 1).

Photo 1: Narrow road with Hopper Brook on left and limited space for a ditch on the east side of road.					
BMP Description: Consider installing larger cross culvert below Merritt property. Install ditch along north side of road across from Hopper Brook. This may involve significant cutting of the slope to install an adequate ditch.					
WQ Benefits	Landowner Support and O&M	Infrastructure Resiliency	Cost and Constructability	Additional Benefits	Total Score (Priority)
9	3	2	3	2	19 (High)
Additional Project Benefits Description: Project implementation will address chronic erosion issues at this site and reduce sediment loading directly into Hopper Brook.

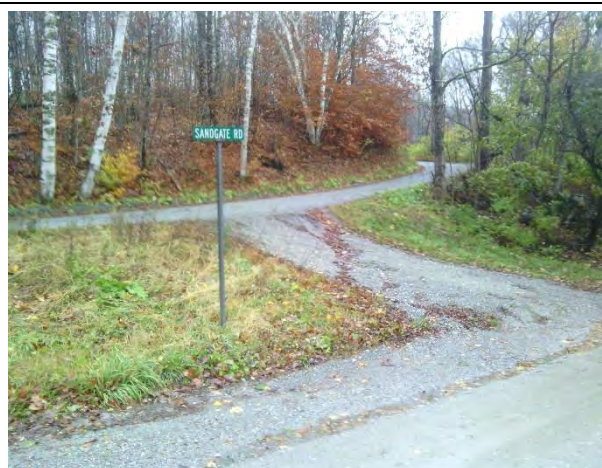
Photo 2: Area of Wuerslin Road to be abandoned for vehicle traffic and turned into a stormwater treatment feature.

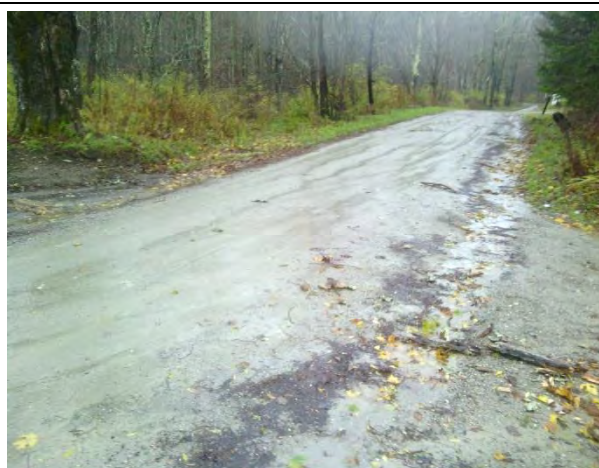
Photo 2: Lower section of Sandgate Road. Runoff is running along the road edge causing rilling and sedimentation downhill.

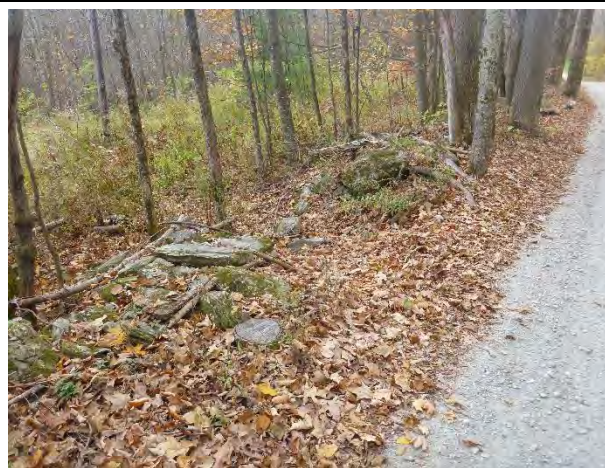
Photo 2: Existing armored turnouts are only partially accessible due to accumulation of road bed material.

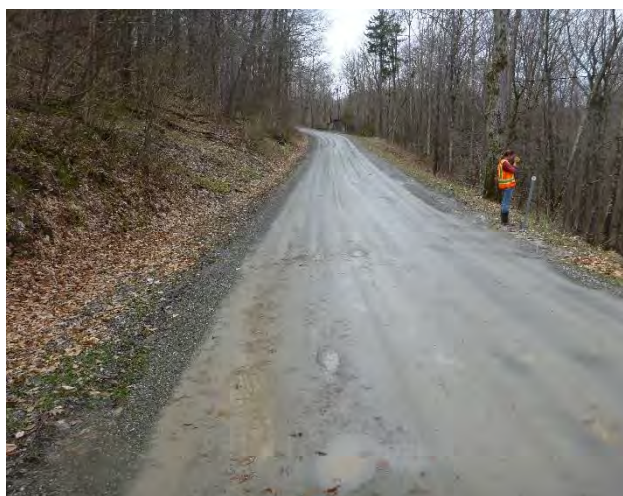
The road crown along a portion of Rupert Road directs water away from the ditch to a steep slope on the northwest side of the road above Terry Brook (Figures 1 & 2). Road runoff has eroded an approximately 50'-tall gully that conveys sediment from the road toward the brook and threatens the road (Figure 3). The slope of the embankment down to the stream is approximately 75%. A small grader berm on the west side of Rupert Road prevents water from sheeting off the road before it reaches the gully.

Figure 2: The road crown does not direct water into the existing ditch and cross culvert along a section of Rupert Road.

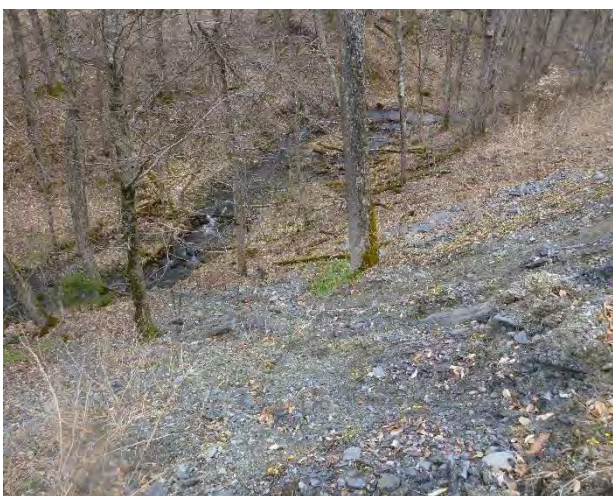
Figure 3: Gully erosion along the steep Rupert Road embankment.

This gully is likely a major sediment source to Terry Brook. The gully erosion threatens Rupert Road, which could require costly maintenance. For instance, FEA observed a failed guardrail that appeared to have slid down the embankment as it eroded. Additionally, the cross-culvert outlet was partially blocked by sediment from the erosion.

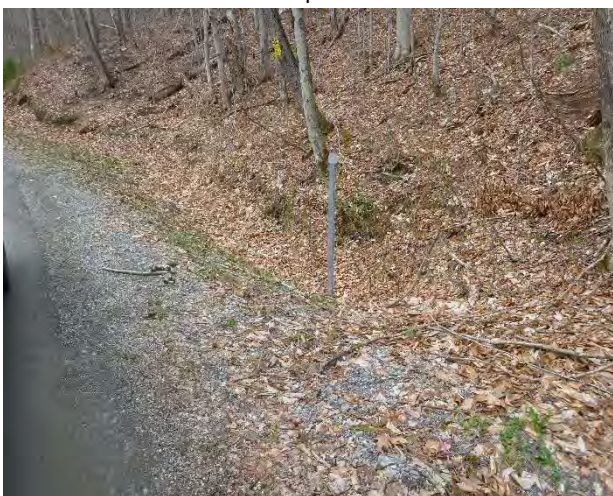
Figure 3: Filling in of the ditch upstream of the culvert may be causing water to spill out of the ditch onto the roadway.

on the area from the header to the edge of the road to prevent rilling of the road edge and erosion of the header. Ensuring the road is crowned and upstream ditch is cleaned out will help direct water into the cross-culvert and may reduce rilling of the road edge (Figure 3).

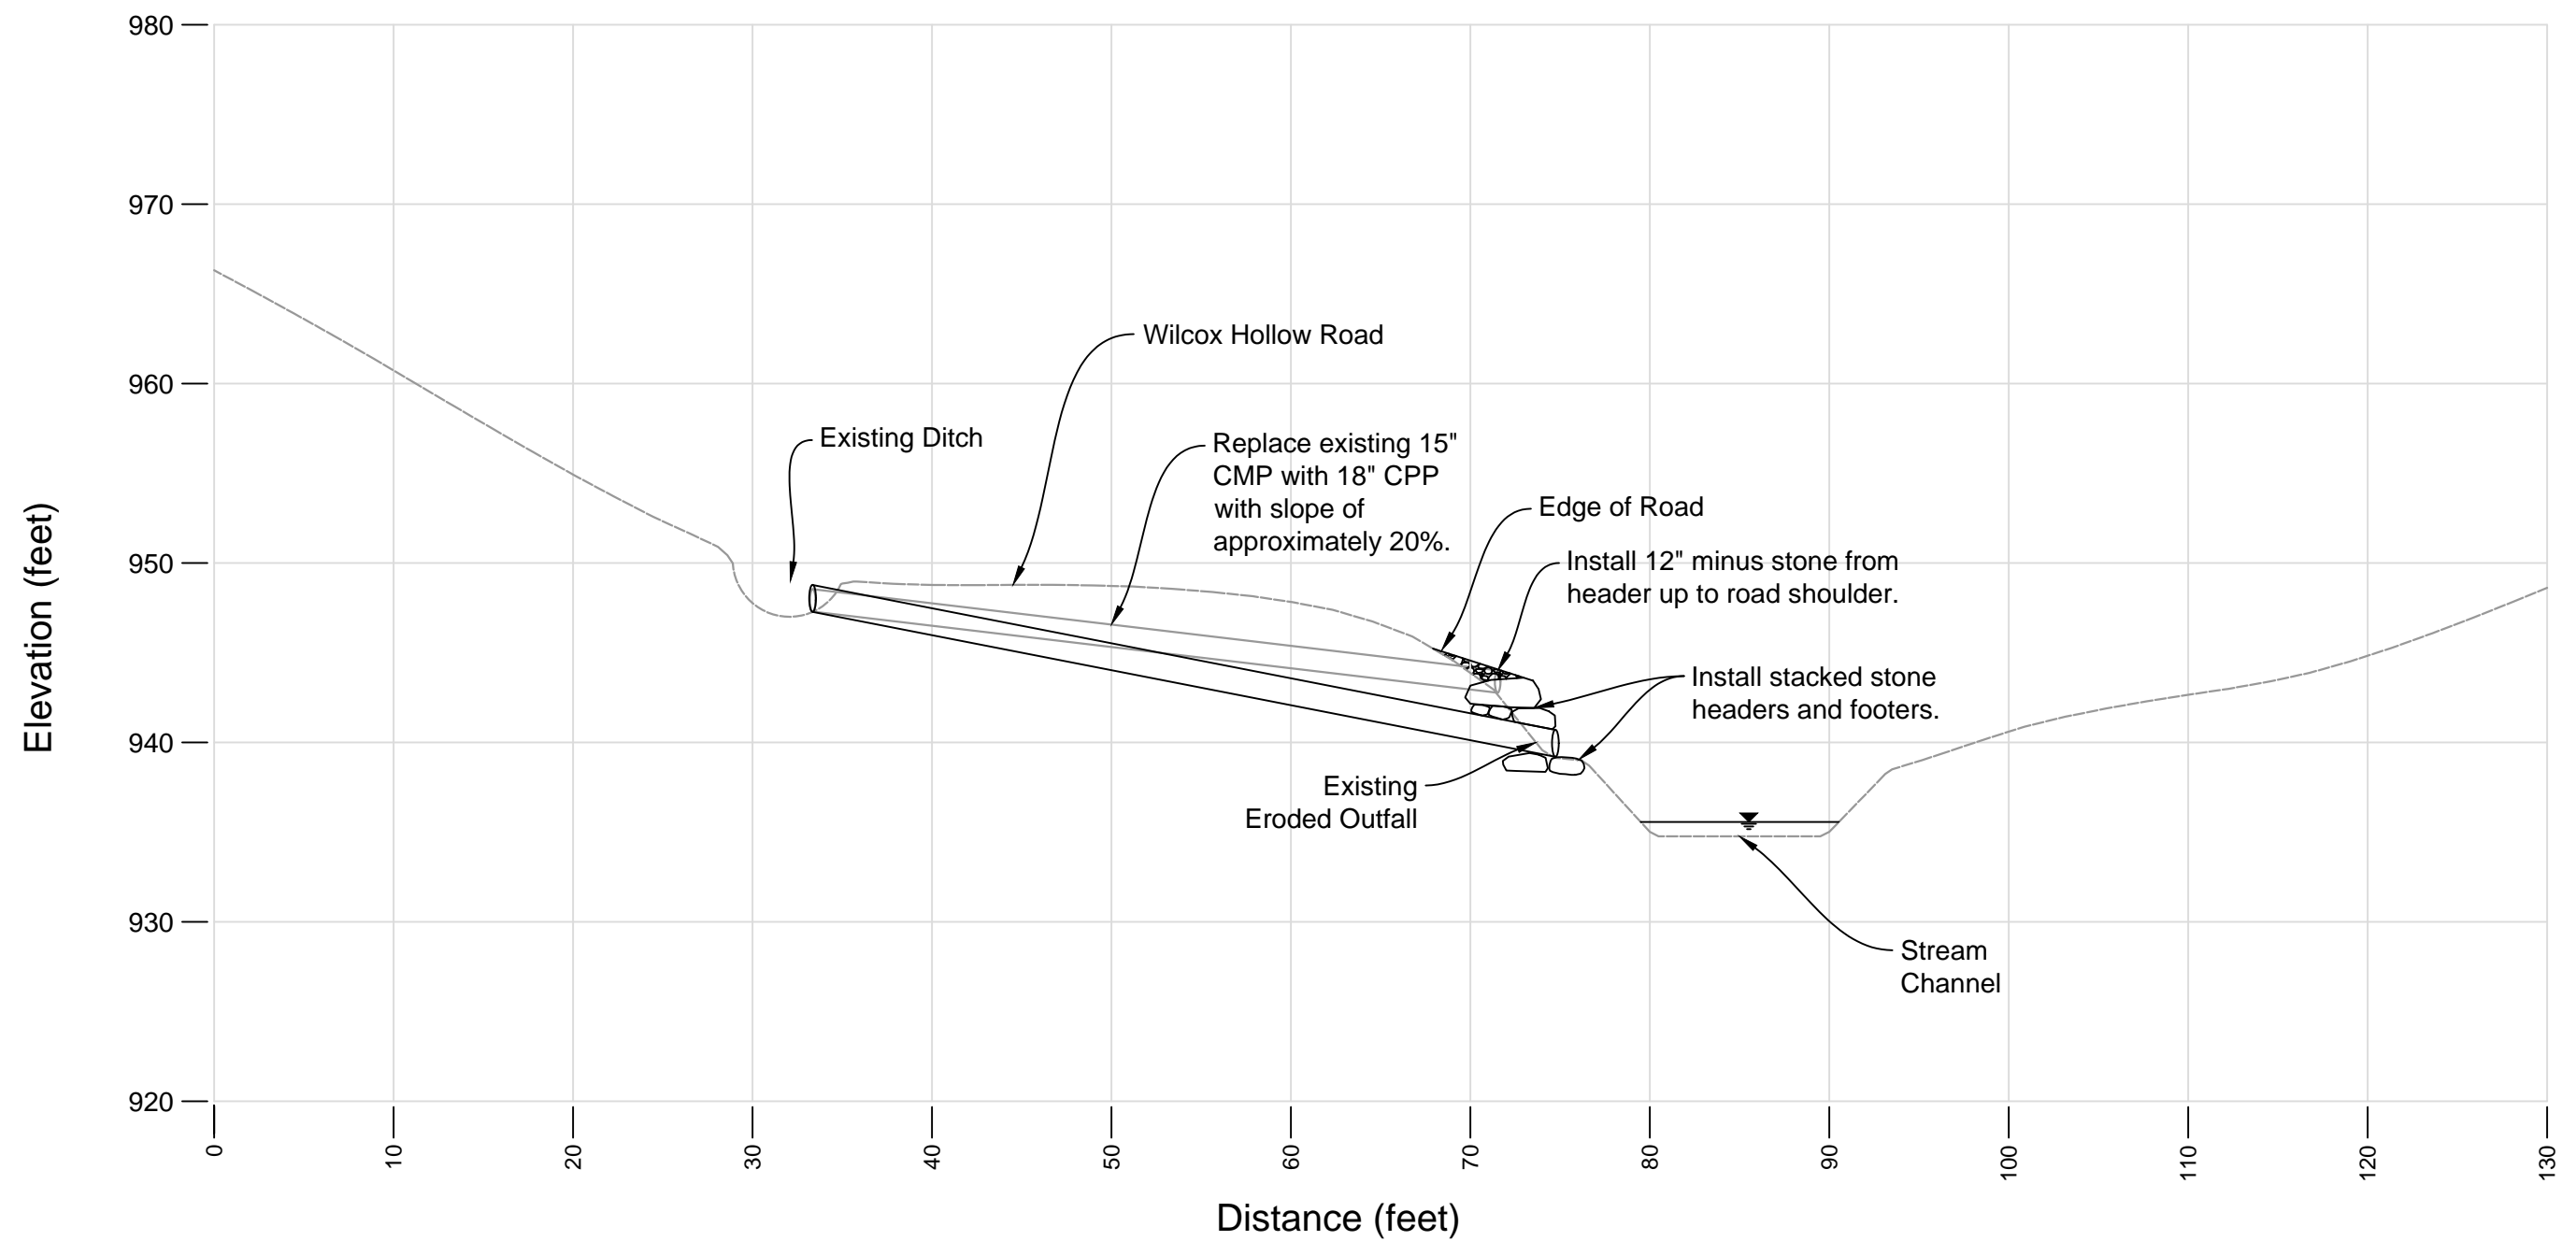
A cross-culvert along Wilcox Hollow Road is undersized and eroding at the outfall (Figures 1 & 2). The 15" corrugated metal pipe conveys water toward a second-order tributary to the Green River. The culvert outlet drops 8-9 feet down the steep road embankment to a second-order tributary to the Green River, causing erosion and sedimentation in the channel. The outlet of the pipe is bent and deformed, indicating a need for replacement. Additionally, water from the road is causing rilling along the road edge.

The erosion along the road edge and embankment is likely a significant sediment source to stream. Additionally, the erosion at the outfall and road edge is a chronic problem area requiring maintenance by the Town. The metal culvert requires replacement due to its condition and size to meet the forthcoming MRGP requirements.
